# Manhole Inspection Summary

Manhole # S67K\_\_001MH

Insp Date: **5/23/08 11:51 AM**

**Location** Address: **600 Dundalk Ave.**

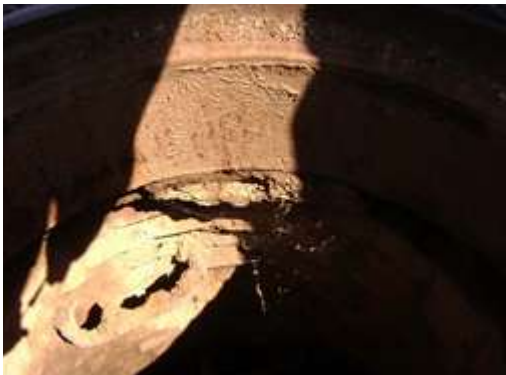
Defect 2

Condition: ☐ Sound ☐ Cracked ☐ Root Intrusion ☐ Loose Brick ☒ **Deteriorated**

Infiltration: ☐ None ☒ **Joint** ☐ Cracks ☒ **Mortar** ☐ Roots ☐ Wall

infiltration evidence at frame seal

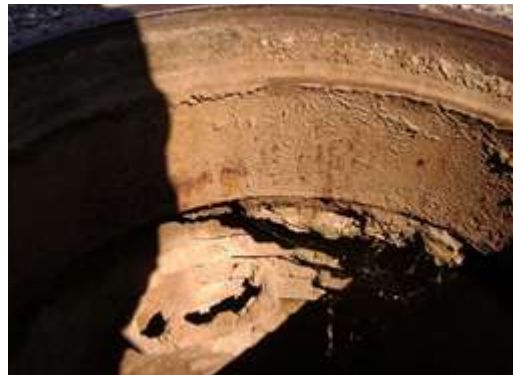
Defect 1

infiltration evidence at frame seal

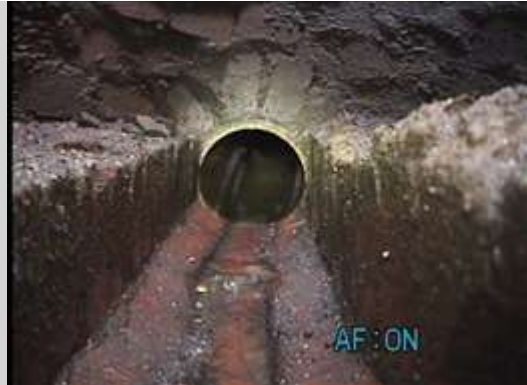
12 O'Clock Outflow

6 in. Circular Gravity Sewer  
Pipe Out @ 12 O'Clock

Pipe Height: 6 (in.) Rod and Bar (Angled)  
Pipe Material: **Clay** ☐ Pipe Lined  
Invert Depth: **8.25** (ft.) Flow Characteristics: **Slow**  
Deposits: ☒ None ☐ Mud ☐ Sludge ☐ Debris ☐ Grease  
Silt Depth: (in.) Deposits Extent:  
Infiltration: **None** Pipe Seal Cond: **Sound**

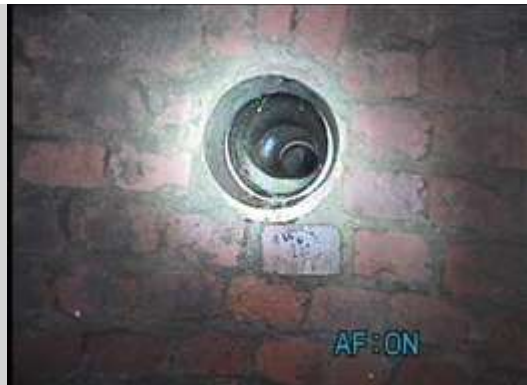
6 O'Clock Inflow

6 in. Circular Gravity Sewer  
Pipe In @ 6 O'Clock

Pipe Height: 6 (in.) Rod and Bar (Angled)  
Pipe Material: **Clay** ☐ Pipe Lined  
Invert Depth: **6.25** (ft.) Flow Characteristics: **Slow**  
Deposits: ☒ None ☐ Mud ☐ Sludge ☐ Debris ☐ Grease  
Silt Depth: (in.) Deposits Extent:  
Infiltration: **None** Pipe Seal Cond: **Sound**

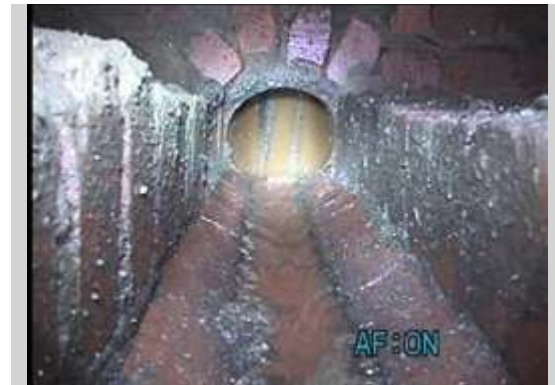
Drop In @ 6 O'Clock

Drop: **Inside** Rod and Bar  
Angled: **Yes** Reading: **6.83** (ft.)  
Inv Depth: **7.83** (ft.)  
Drop Condition: **Open**
